# **INDOOR AIR QUALITY ASSESSMENT**

**Executive Office of Health & Human Services  
Service Center  
49 Nursery Lane  
Fitchburg, Massachusetts**

Prepared by:  
Massachusetts Department of Public Health  
Bureau of Environmental Health  
Indoor Air Quality Program  
September 2019

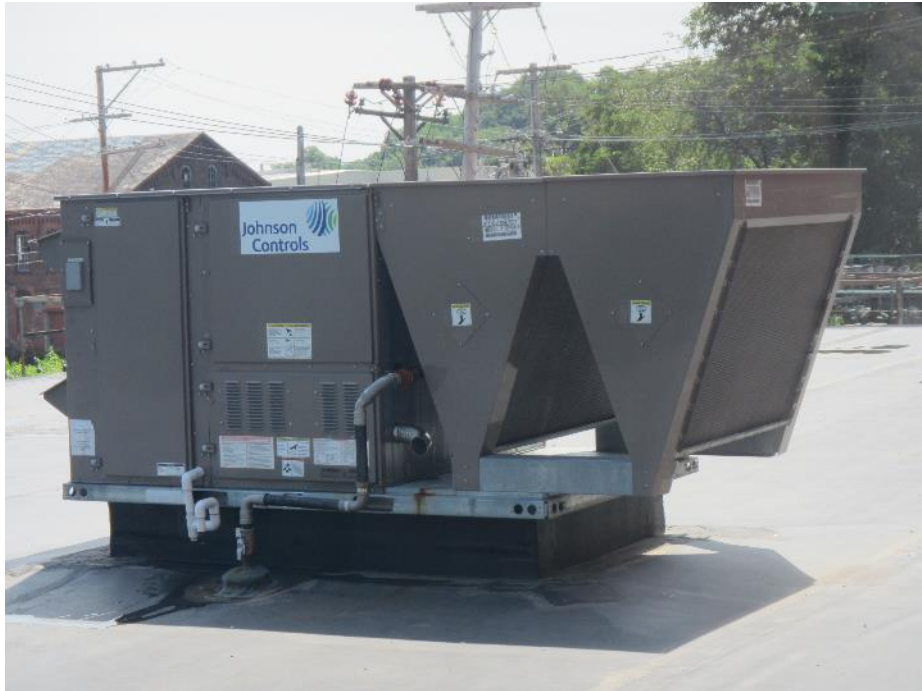
**Picture 1**

The HVAC system in the EOHHS space consists of large rooftop air handling units (AHUs) that draw in fresh air from intakes on the roof and supply fresh air to supply ducts (Pictures 1 and 2). Return air is brought back to the AHUs through ceiling-mounted return vents (Picture 3).

**Roof-mounted AHU**

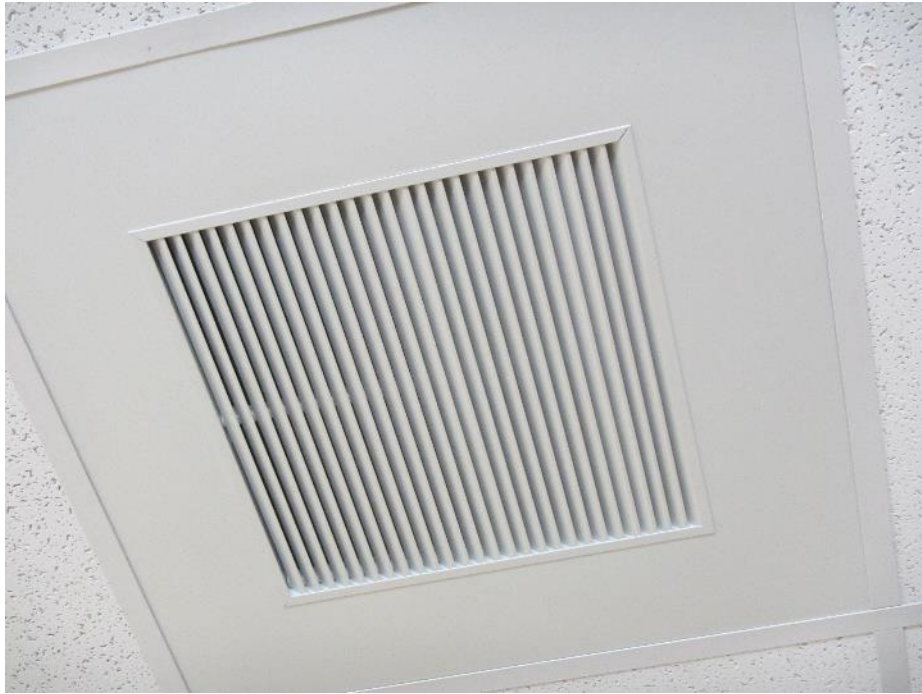
**Picture 3**

**Ceiling-mounted return duct**

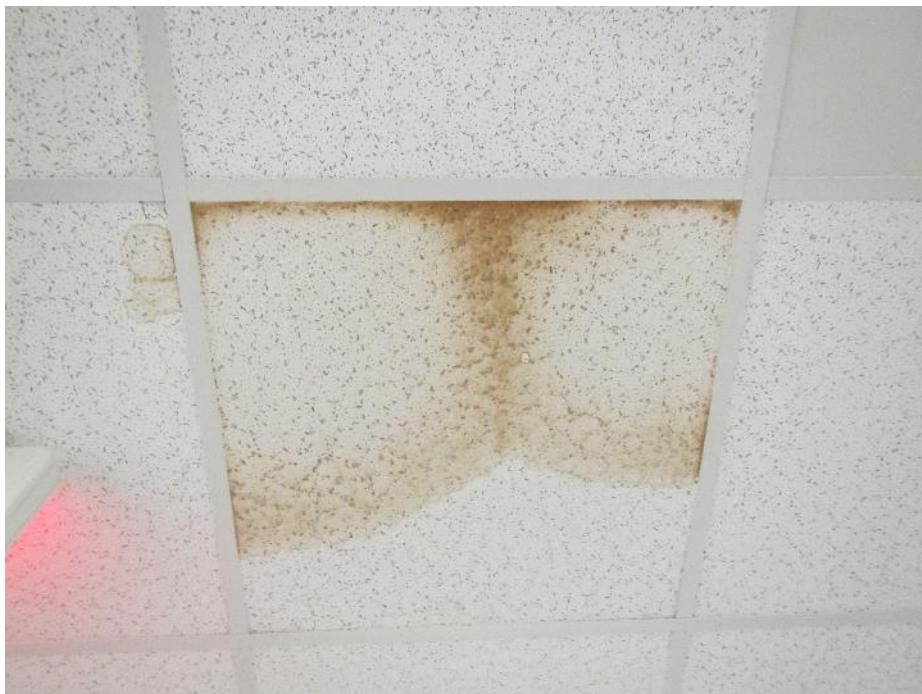
**Picture 4**

BEH IAQ staff noted some water-damaged ceiling tiles on the first floor (Picture 4). This leak was reported to be active and is located at the intersection of the first floor addition and the second floor wall. Building management was reported to be aware of the issue and is actively undertaking repairs to address the leak. Porous building materials (e.g., carpeting, gypsum wallboard, ceiling tiles) that are not dried within 24 to 48 hours of being wet may support mold growth and should be discarded if water-damaged. BEH IAQ staff did not observe any visual signs of mold growth or any musty odors during the assessment.

**Water-damaged ceiling tiles above DMH space on first floor**

2. Continue efforts to stop the active water leak at the intersection of the first floor DMH roof and second floor wall.
3. Monitor any areas of suspected water infiltration and ensure porous building materials are dried within 24-48 hours. Discard any water-damaged porous materials (e.g., ceiling tiles) that have not been properly dried. Refrain from storing porous items in areas of known water infiltration.

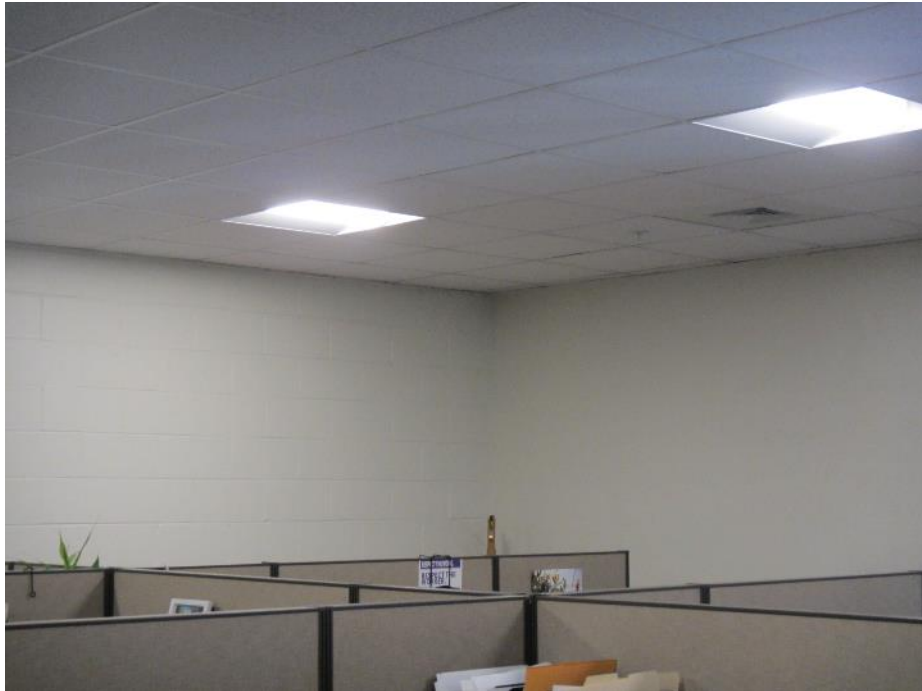
**Picture 5**

Some occupants reported complaints regarding cold temperatures in the winter as well as during summer months. One area on the first floor adjacent to a concrete block wall corner was of particular concern to occupants (Picture 5). This area appeared to be an addition to the original building and likely does not have adequate insulation. DMH facilities staff reported that they will investigate methods of adding supplemental heating to this area for winter months. Other occupants reported being cold due to being directly in the air stream of supply air diffusers. This situation can overcool an occupant as well as contribute to eye irritation due to the cold, dry air stream with air conditioning. Occupants further reported that the HVAC contractors have been trying to adjust the controls to provide for more comfort in the space. Due to the construction of the former mill building, this task has been difficult.

**Concrete cinderblock corner with frequent cold complaints**

5. Continue to explore supplemental heating options in the DMH corner where most winter temperature complaints have originated.
6. Consider installing local exhaust ventilation in the kitchen areas to remove excess humidity, odors, heat, and particulates.
